SIO REFERENCE SERIES

DEEP MOORED INSTRUMENT STATION CRUISE REPORT

NORTH PACIFIC STUDY
Cruise 2

U.S.C.G.C. ACUSHNET
November 19 to December 19, 1968

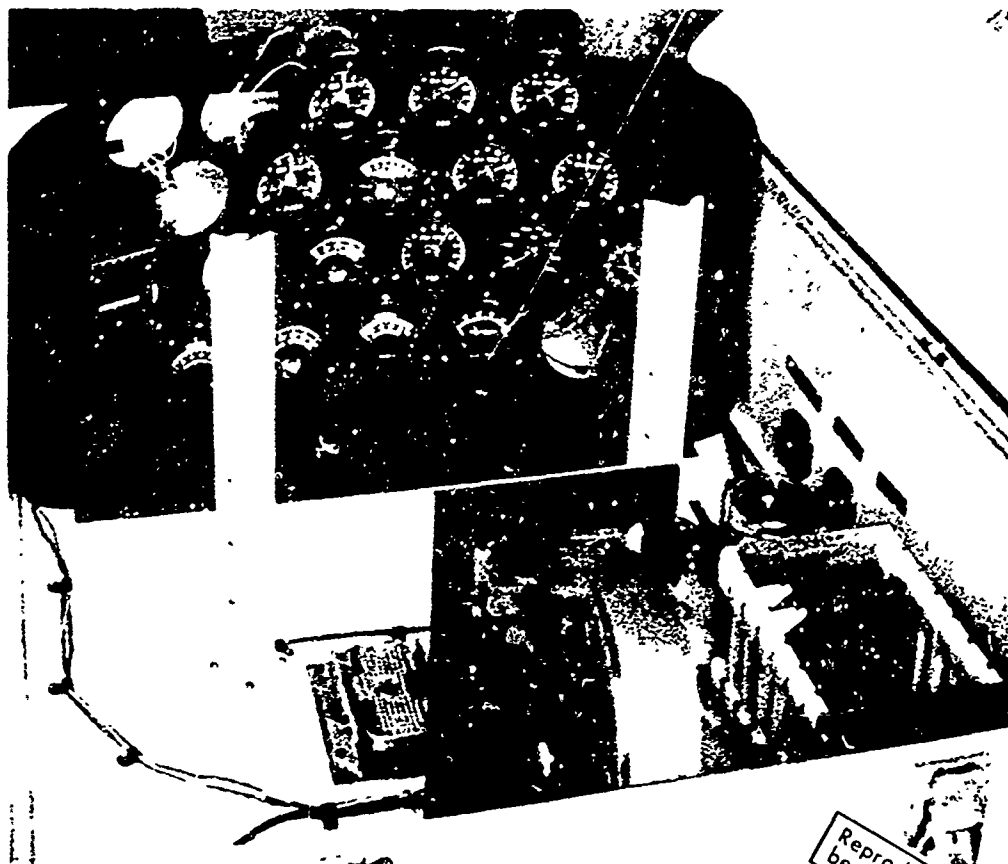
Opened instrument box showing instrument panel and panel light frames.

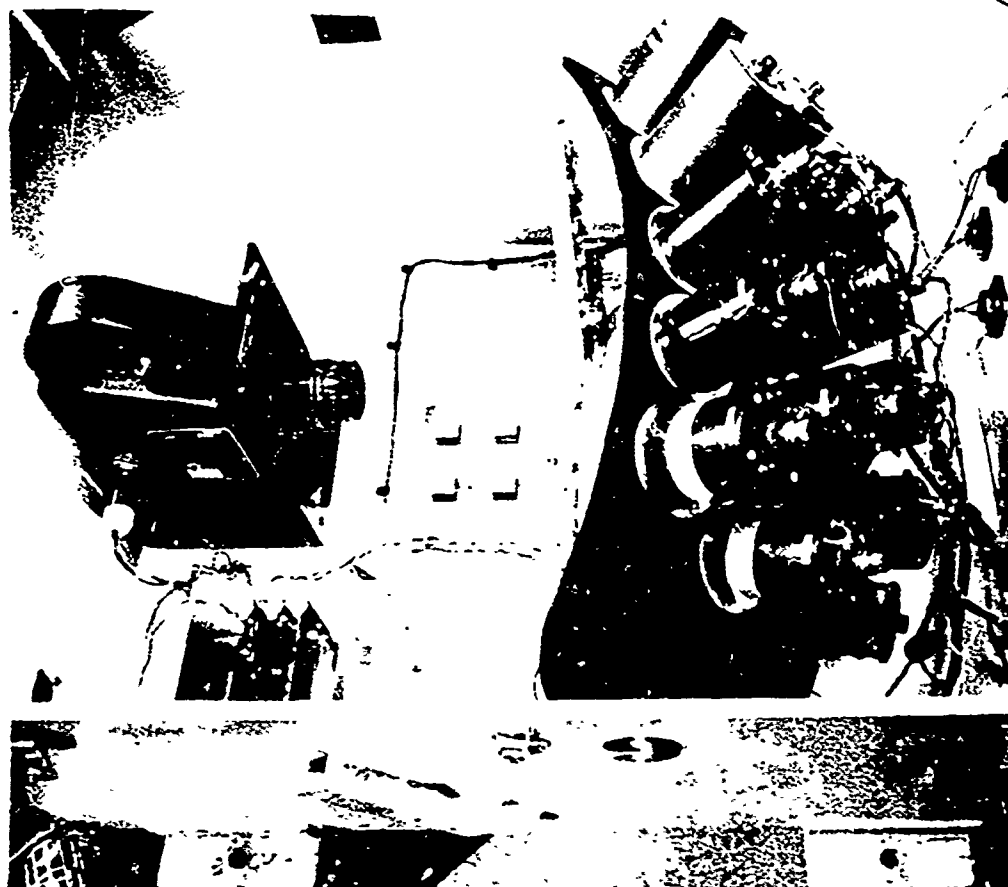
Instrument box showing camera with instrument panel tipped forward for servicing.
